# The Use of Infrared Thermal Imaging for Home Weatherization

**John Snell  
Matt Schwoegler  
The Snell Group**

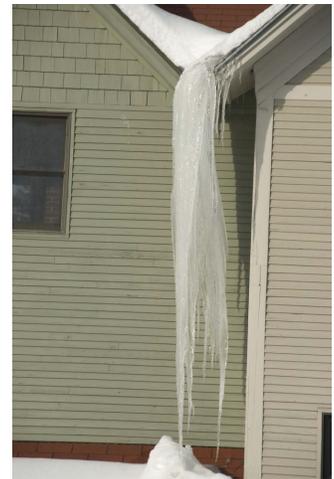
*Figure 1: Icicles like this are a good indication of poorly performing insulation and/ or ventilation.*

Often the problems—as well as their causes and consequences—simply cannot be seen or may reveal themselves only after significant damage has been done. Homes in the “snow belt” (Fig. 1), for example, can end up with extensive ice dams resulting from roof/ceiling insulation and vent systems that do not perform adequately. Air leakage can also prove very problematic or time consuming to understand and reduce. One of the most troubling problems any WAP auditor faces is determining where insulation exists—and doesn’t—in an existing home. Success in correcting problems like these is often illusive because we cannot “see through walls” and the root causes are not obvious.

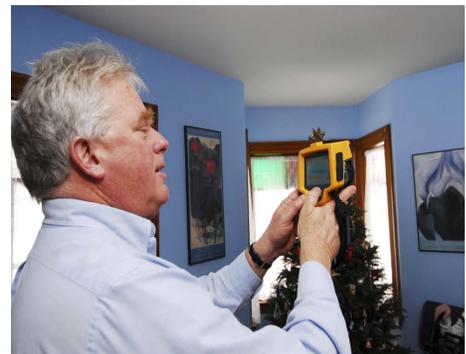
*While modern infrared cameras are lightweight and easy to use, accurately interpreting the image typically requires more training and experience.*

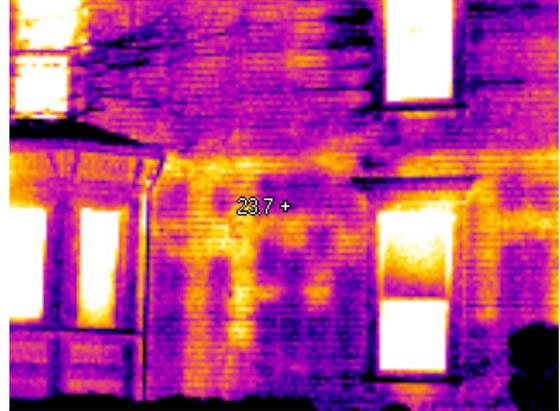
Figure 3: Improperly installed insulation can yield an irregular thermal pattern.

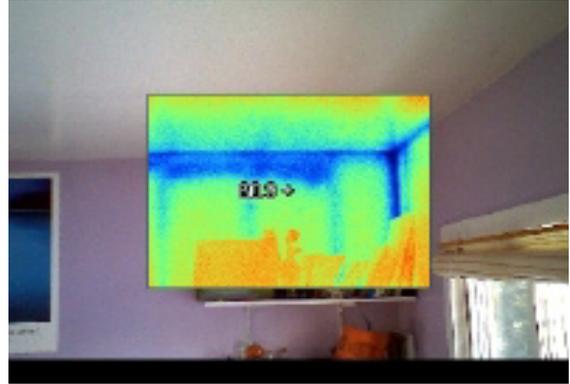
Figure 4: Properly installed cellulose is an excellent insulation. Unfortunately it is often poorly installed with missed areas and settling the most common quality problems.

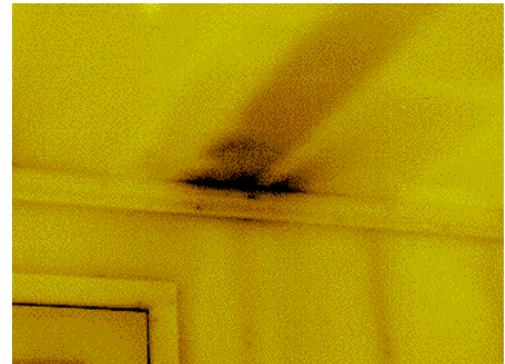
Figure 5: Batt insulation is susceptible to air infiltration. The fiberglass shown here does not stop airflow directly into the home or indirectly into the ceiling section.

As has been well documented in the WAP, excessive air leakage can account for up to half of the energy used to condition buildings. Of course adequate air exchange is essential for the occupants’ health and safety, but most buildings have a far higher rate of air exchange than is necessary. The problems can be as straightforward as a failed door weather seal or as complex as an air pathway through a plumbing chase in an interior wall or ceiling plenum. The leakage pathway is often complex and, without infrared, extremely difficult to visualize (Fig. 5).

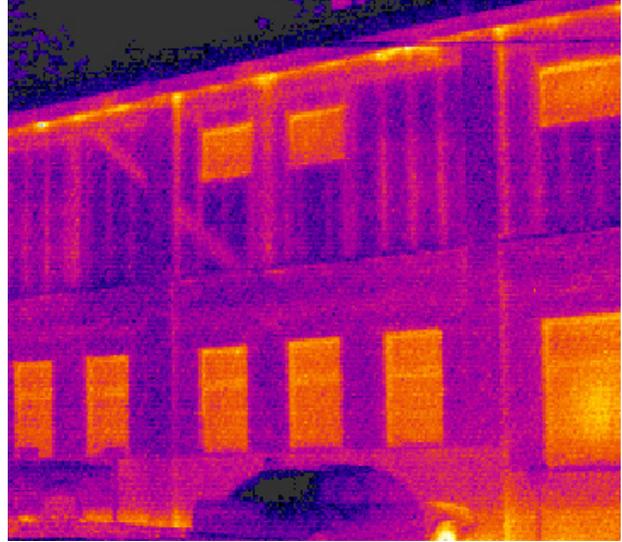
*Figure 6: All the framing and insulation is clearly visible in this apartment building. Pressure differences in the building, known as stack effect, result in air leaking past the envelope through various pathways and exiting out near the top plate of the wall. The fiberglass batt insulation does little to slow the movement of air.*
